Using the flexible tube, treat the following areas.

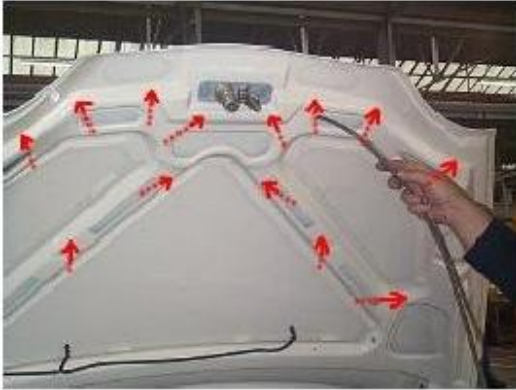
Bonnet.

Treat frame cavity around periphery.

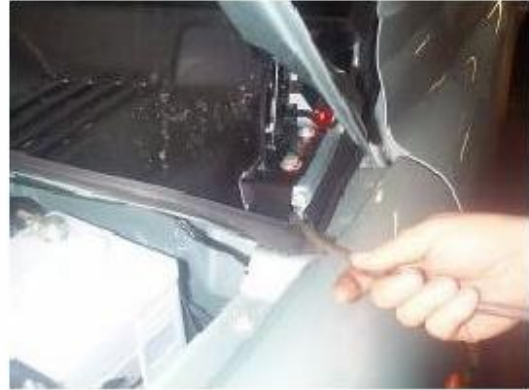
Bonnet hinge reinforcement.

Treat area below bonnet hinge reinforcement. Access through cavity below bonnet hinge, behind plenum finisher.

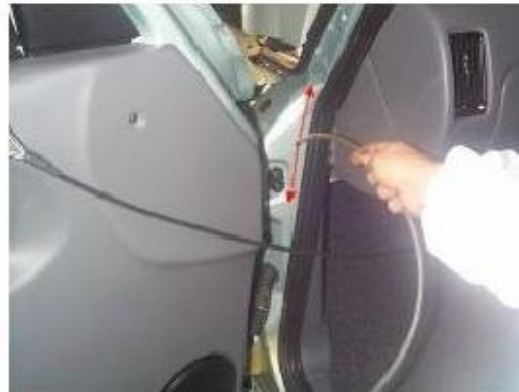
'A' Post lower.

Access through hole adjacent to courtesy light switch. Remove blanking plug. Feed tube down into cavity to full extent. Withdraw tube whilst spraying. Feed tube upwards into cavity and re-apply. Wipe off excess product from painted surfaces. Coat new plug with product prior to fitting.

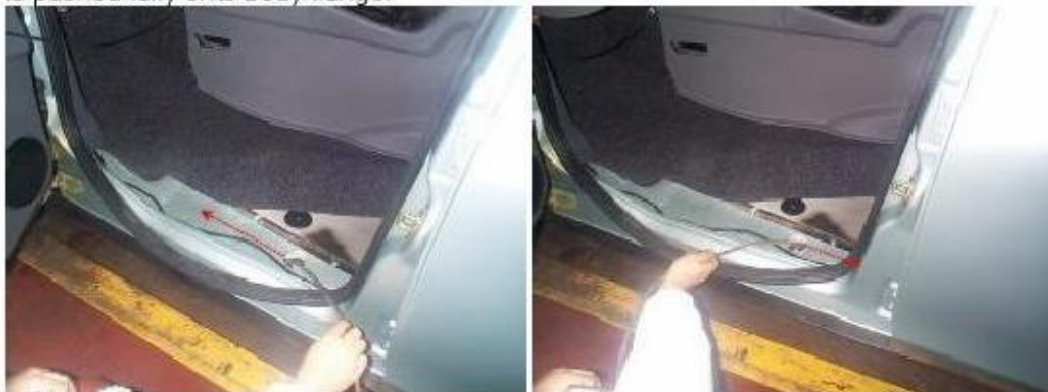
Front floor extension.

Carefully remove the front door primary seal adjacent to the treadplate. Remove the three screws which attach the front door treadplate to the floor. Lift the carpet, noting it's fitting around the centre division. Move the carpet to allow access to the blanking plug and retain for refitting. Feed tube forwards into cavity to full extent. Withdraw tube whilst spraying. Feed tube rearwards to full extent and re-apply. Re-fit blanking plug. Replace carpet, paying particular attention to fitting around / below centre division. Re-fit treadplate using three fixing screws. Take care to avoid piercing electrical wiring harness. Replace primary door seal, ensuring seal is pushed fully onto body flange.
