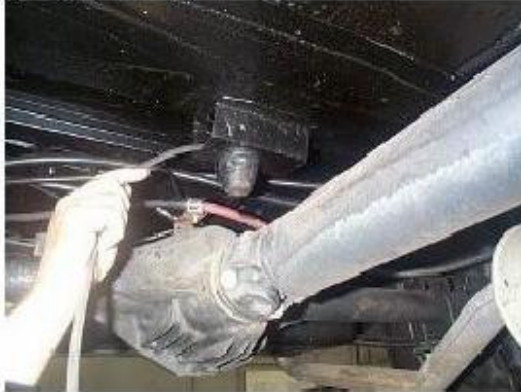
02069

Rear axle snubber.

Treat area between rear axle snubber and vehicle floor,
(photo 02069)

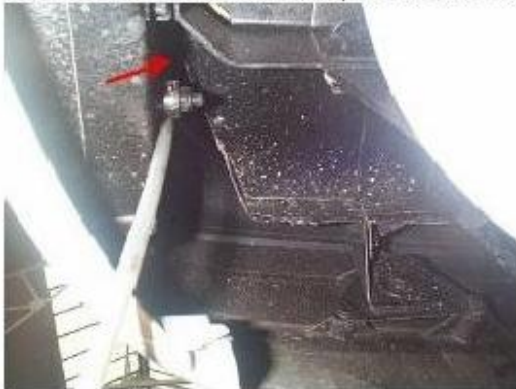
Rear wing inner and outer.

Access through rearmost outer corner of body, inside of rear bumper end cap.
Feed tube forward into cavity to full extent. Withdraw whilst spraying.
